Polychlorinated Biphenyls (PCBS) Source Removal Project Report and Management Plan

Westport Middle School
400 Old Colony Road, Westport, Massachusetts

Westport Community Schools
17 Main Road, Westport, MA

April 1, 2013

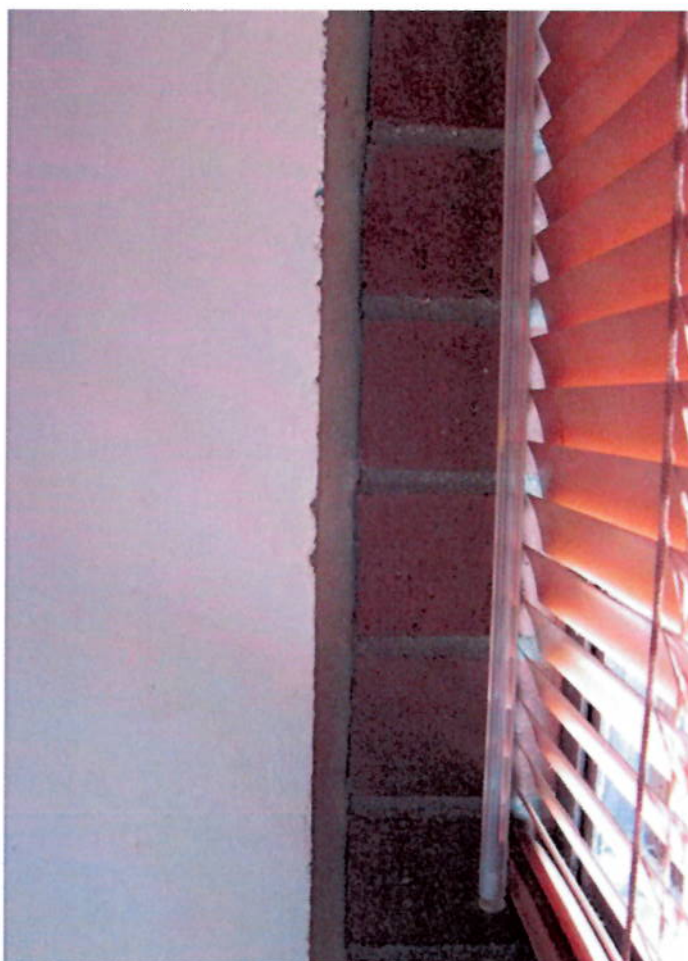
Identified suspect materials included locations of interior caulking at columns, a foam filler at concrete beams and columns, mastic/felt above tectum ceiling panels, white plaster material at air intake at unit ventilators, and homasote insulation at roof air intake ducts. Of the sampled materials regulated concentrations of PCBs above 50 ppm were identified associated with interior caulking at columns, the foam filler at concrete beams and columns, mastic/felt above "tectum" ceiling panels. The significant sources of PCB Bulk Product included more than 70,000 square feet of ceiling mastic and caulking both interior and exterior to the building. Refer to **Appendix G** for additional bulk sample laboratory analysis results and chain of custody on June 27 and 29, 2011.

Interior Caulking

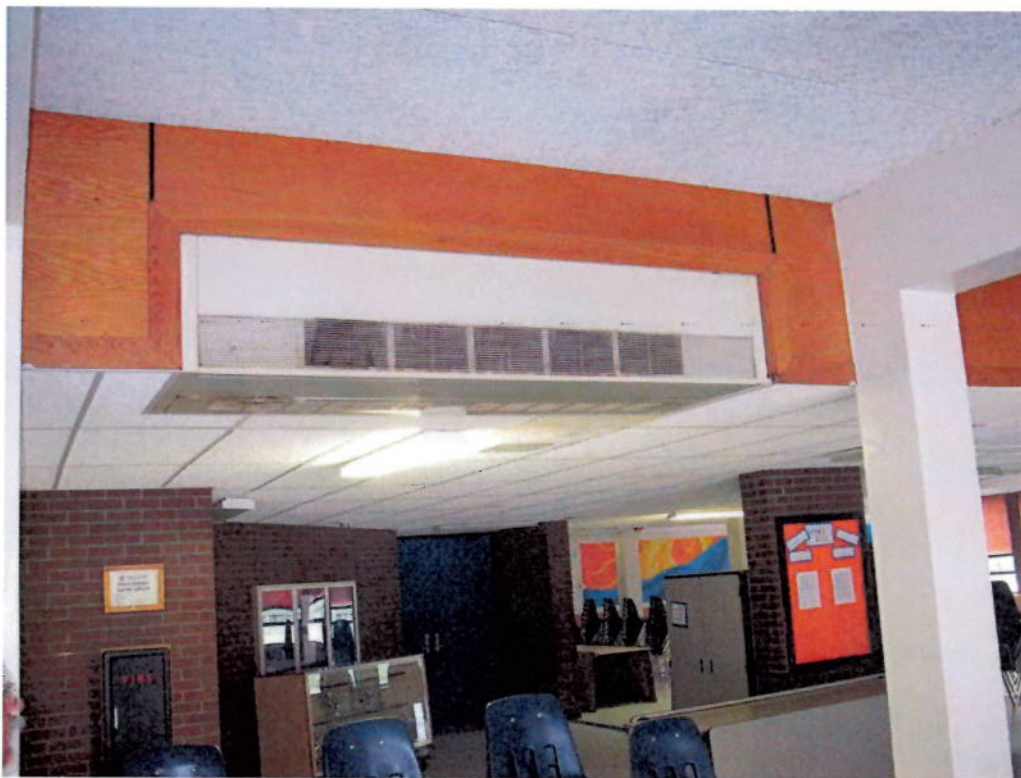
Interior Showing Tectum Ceilings and Overhead Unit Ventilators in Cafeteria

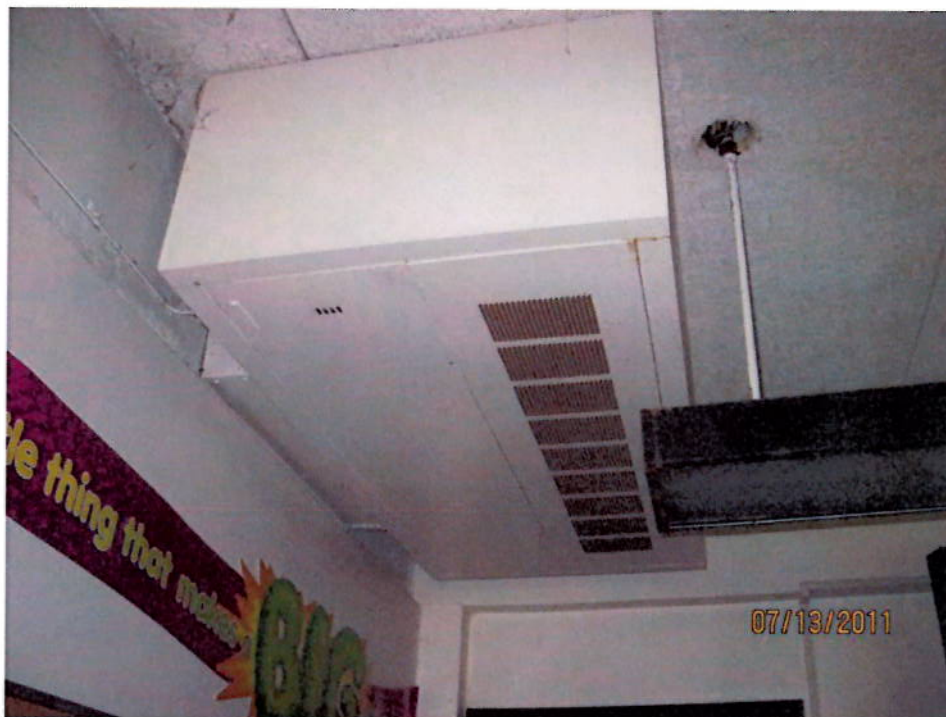
Interior Showing Tectum Ceilings and Overhead Unit Ventilators in Classroom

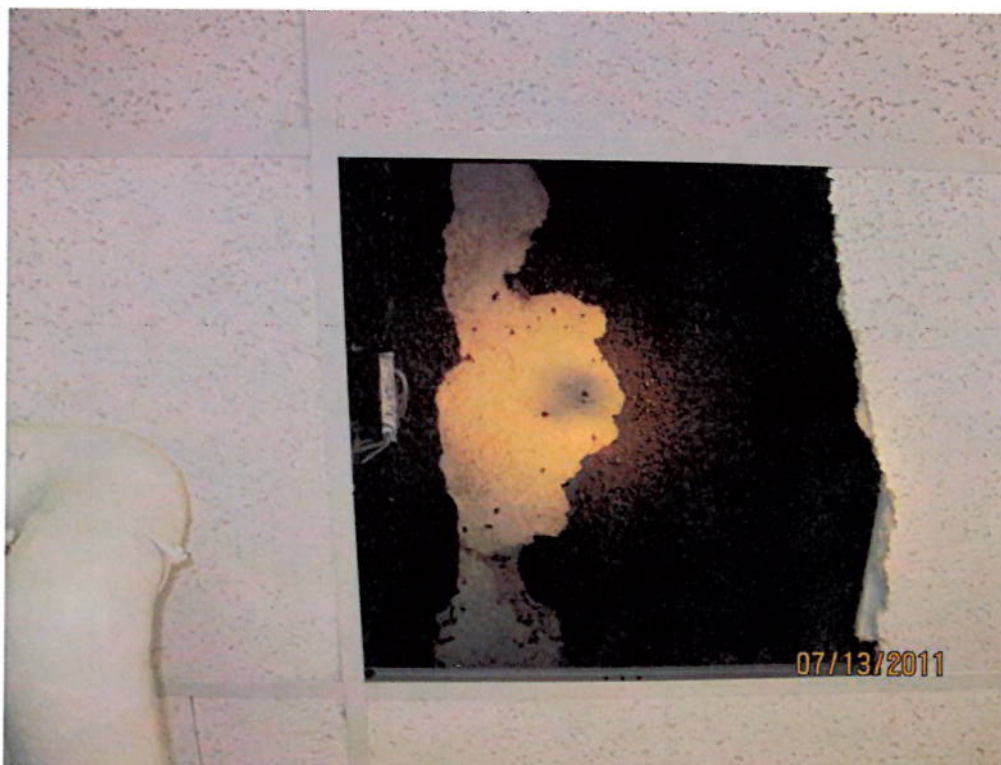
**Interior Showing PCB Mastic above Tectum Ceilings
(note location where tectum removed and drop ceiling present)**

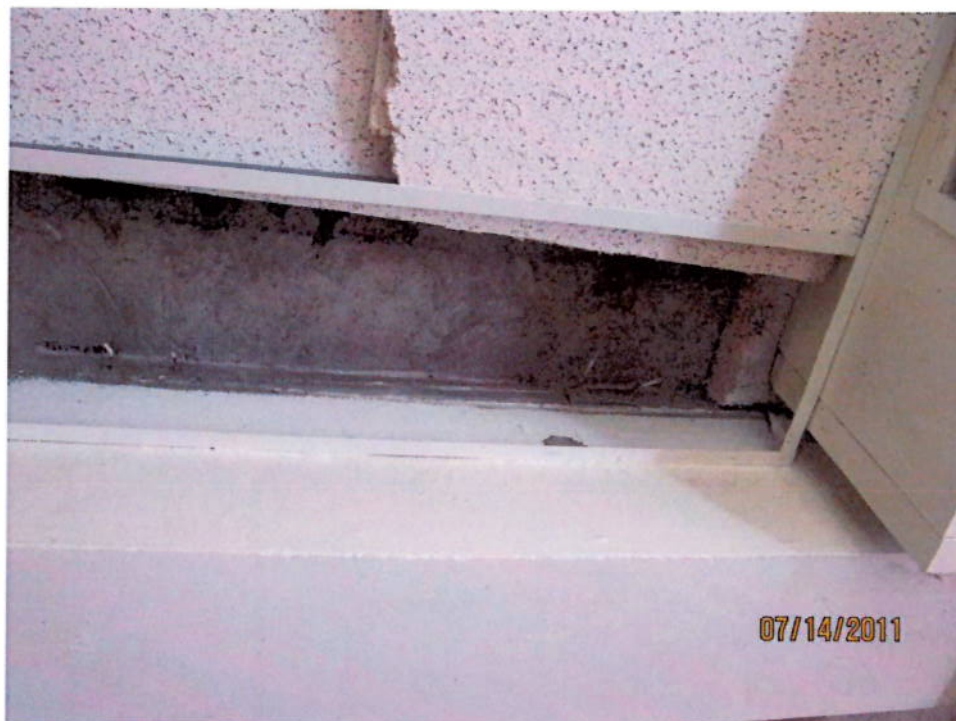
**Interior Showing Tectum Ceilings at location of beam
where removed in lower level**

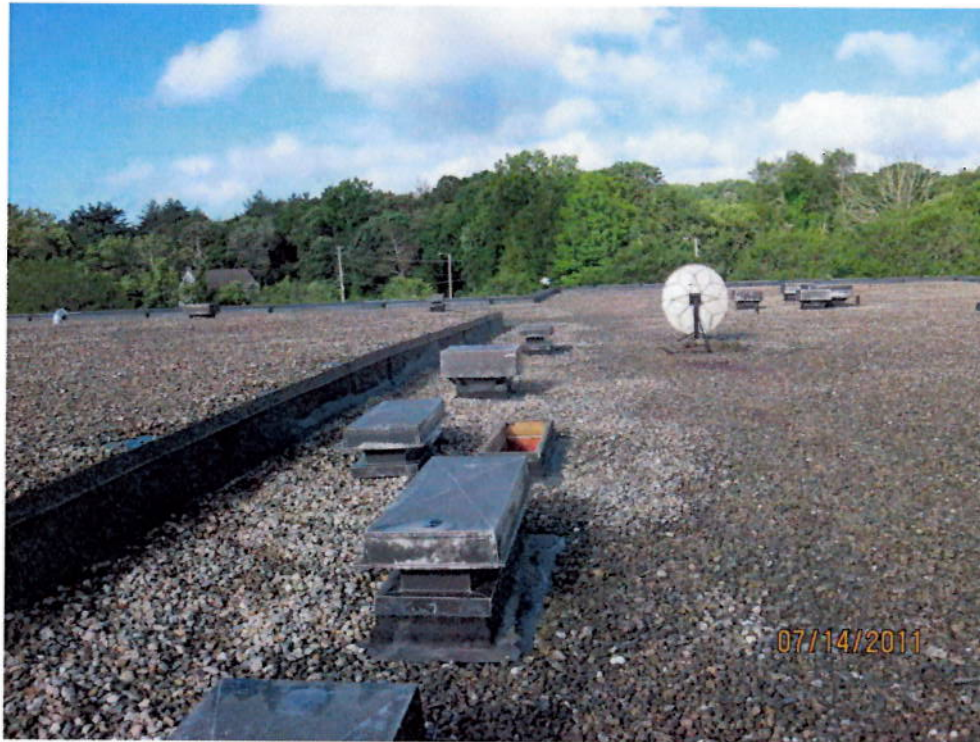
Exterior Showing Roof and open roof top air intake

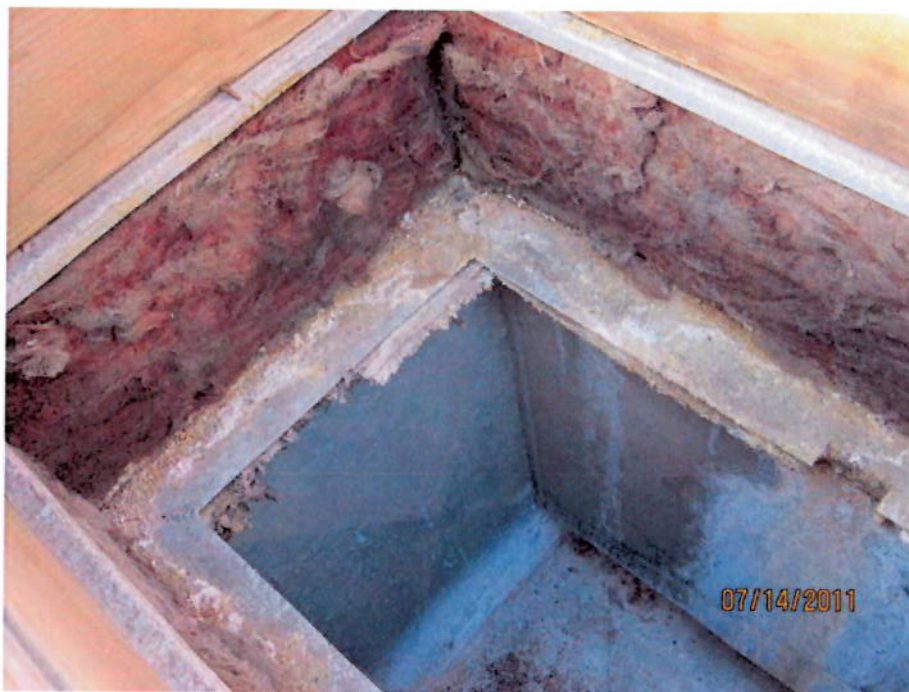
Exterior Showing close view of air intake at roof
